Department of Energy  
Office of Legacy Management

**Subject: Transmittal of the June 2008 Fernald Site Inspection Forms**

# FERNALD PRESERVE FIELD WALKDOWN INSPECTION FORM

**Fernald Preserve  
Consolidated Finding Locations  
for June 2008 Site Inspection**

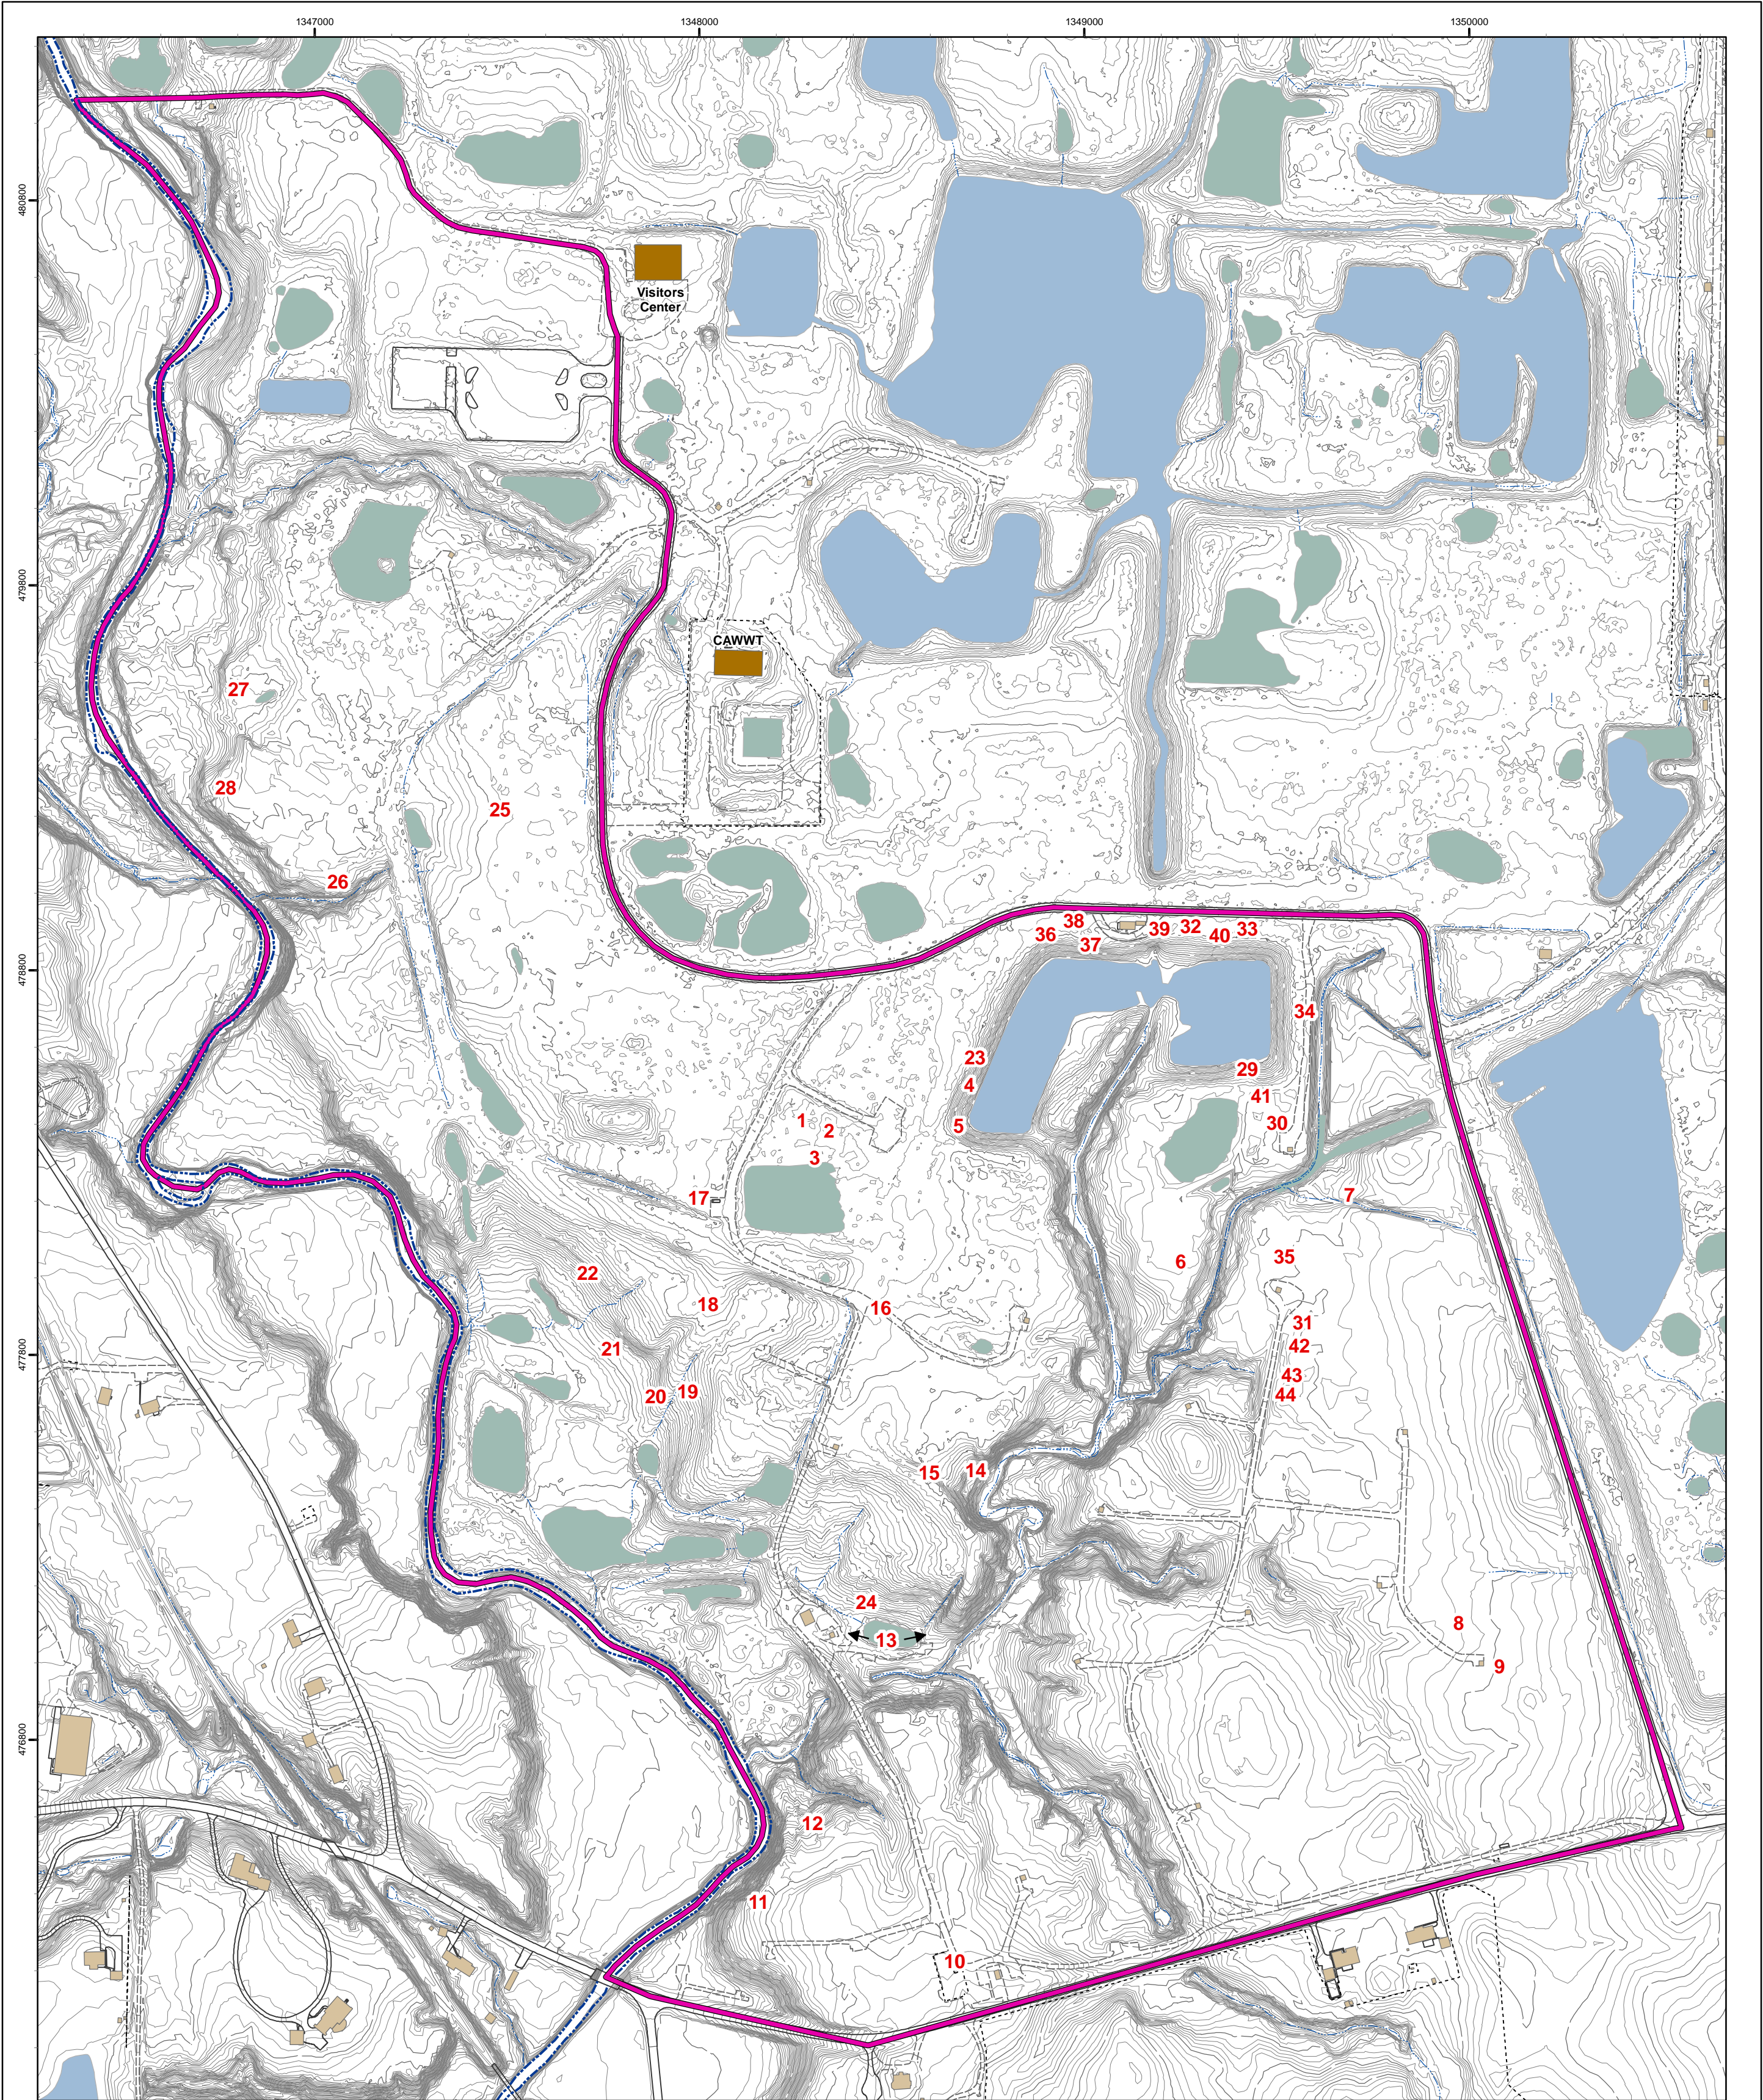
NOTE: Findings are numbered and provided on the June 2008 Field Walkdown Form.  
NOTE: Paddy's Run will be inspected as accessible - Summer/Fall.
